Route Kato Gatzea - Aghios Giorgios (first section of the South Pelion Way)

Checked by Julie Carpenter

Date 15 October 2023

Condition Original route impassable, use alternative route

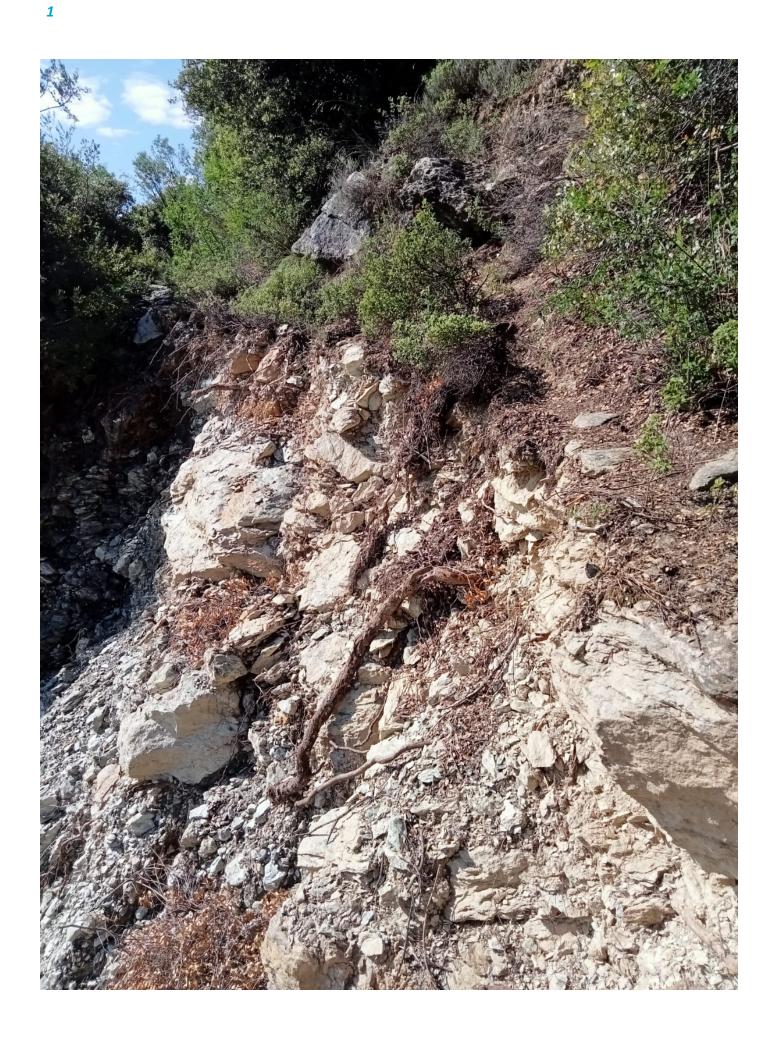
There is a major landslip down onto the railway that has taken most of the kalderimi with it, just where the lovely kalderimi turns right out of the canyon to go parallel and above the railway (pictures 1 and 2).

The path is really impassable and what is left behind would collapse if walked on.

Alternative route is to turn back down to the railway and walk along it away from Ano Gatzea until you can turn right up the road by the goat and sheep pens. That road leads up to Aghios Giorgios and the kalderimi meets and crosses it about 1 km up which is where you can rejoin the proper path, all fine from thereon up to Aghios Giorgios.
