**Route**                **Lafkos - Milina - Lafkos**  
**Checked by**        **David Lewis**  
**Date**                **24 September 2023**  
**Condition**         **One route passable with caution, one route not passable**

*Routes A and B, Lafkos - Milina and Milina - Lafkos*

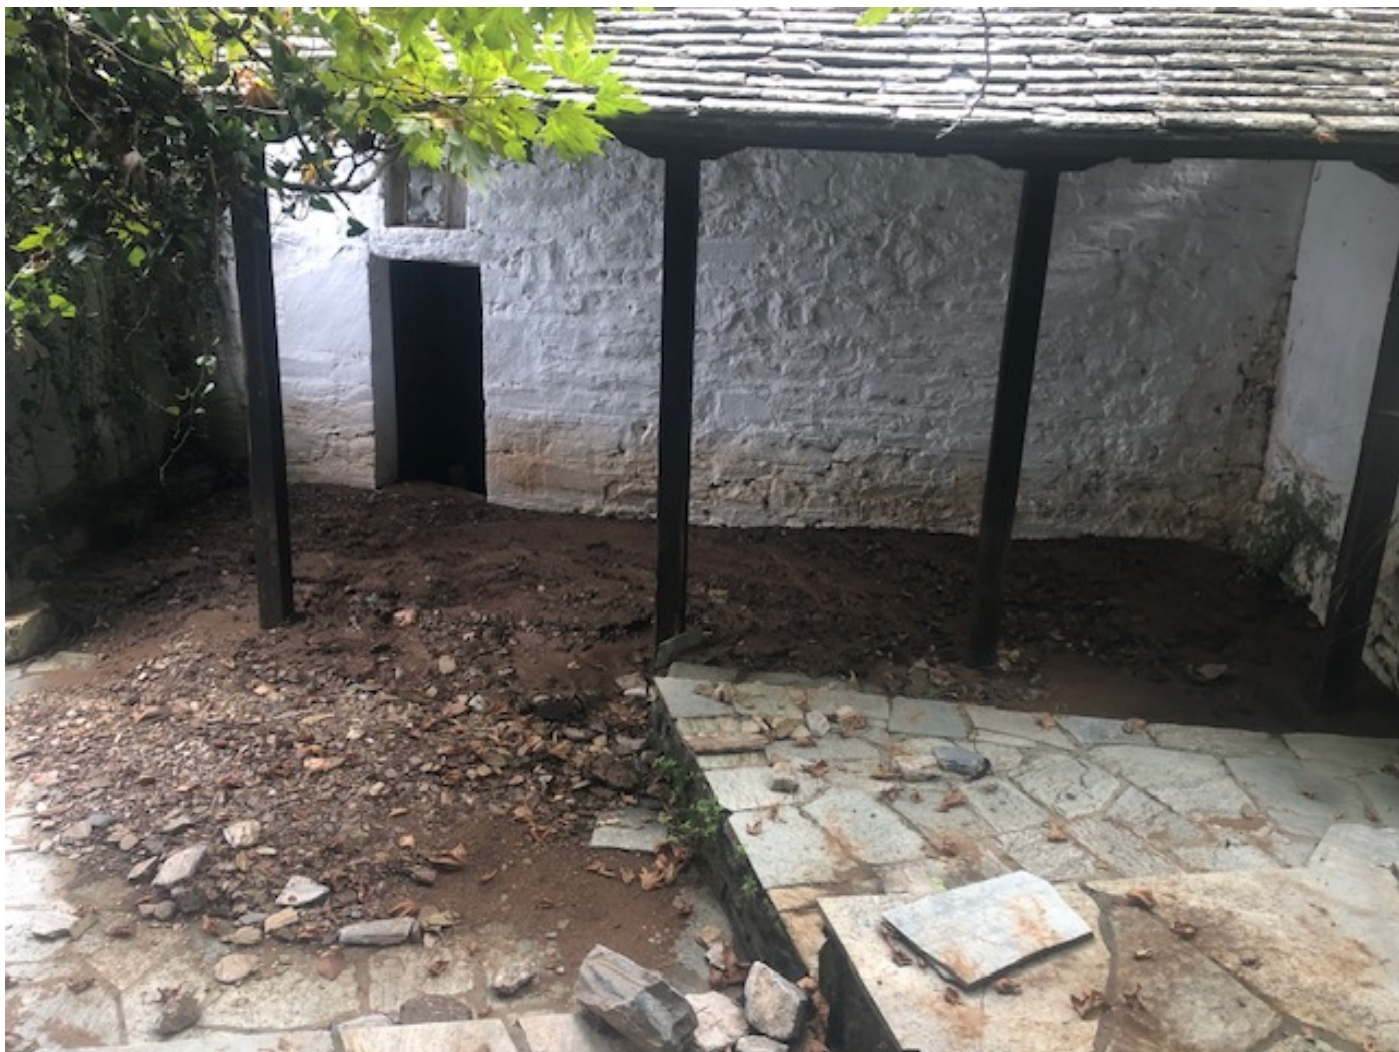
Photo 2: The middle section of the kalderimi from Lafkos to Milina, where the little chapel is located. As can be seen from the photo lots of soil/ silt has been washed down the hill and collected outside the chapel. There is also silt and water inside the chapel which will damage the floor and objects inside.

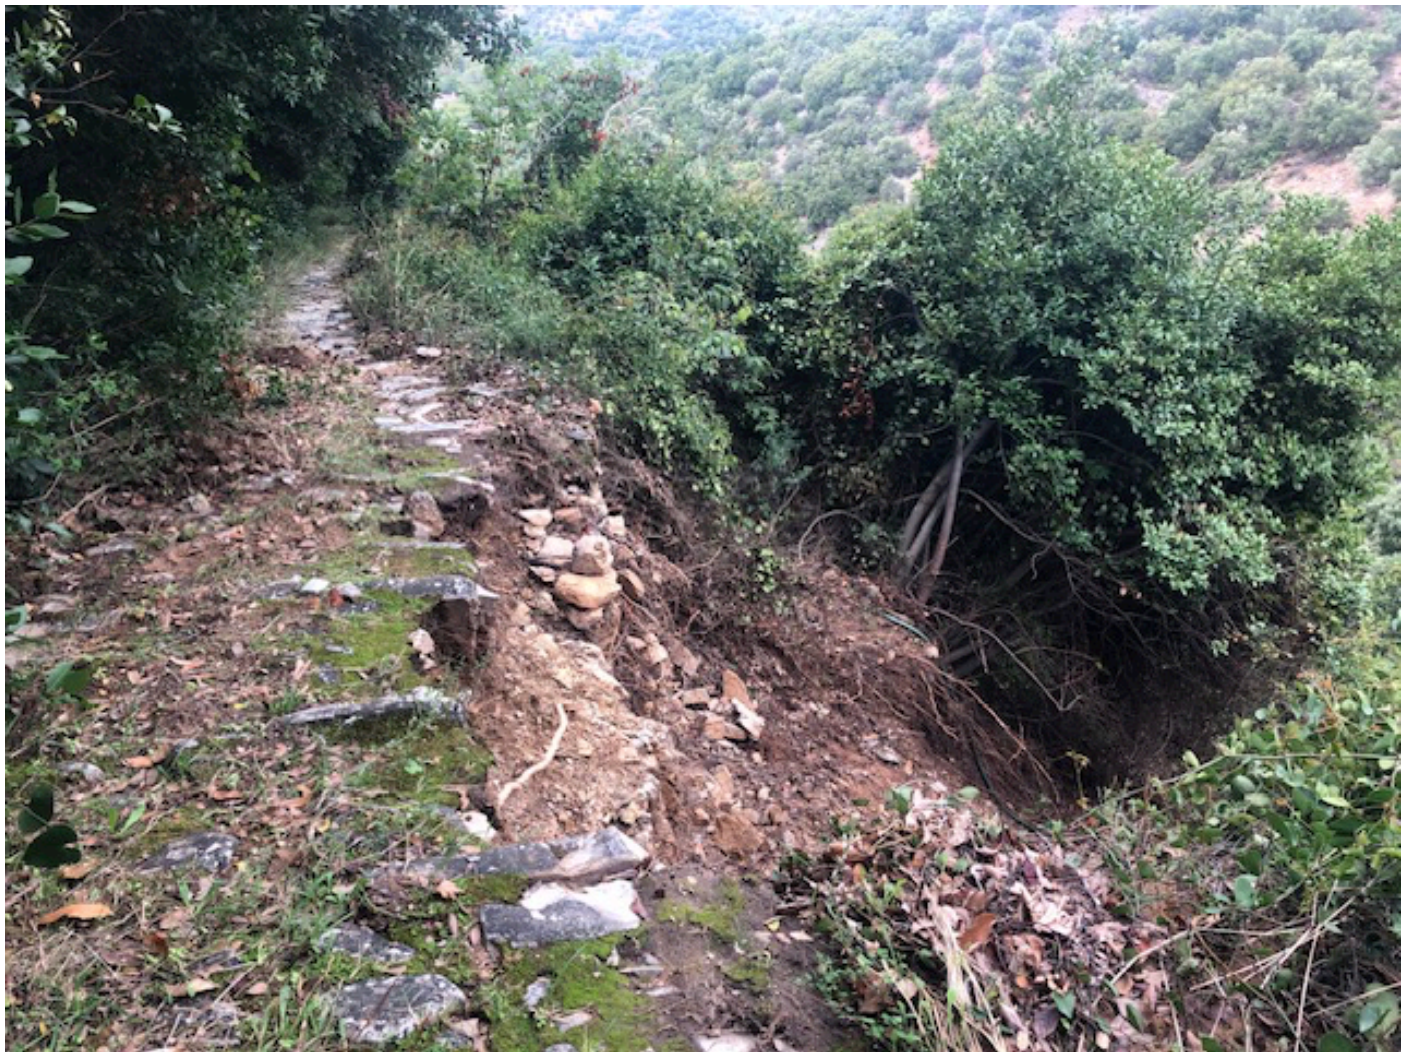
Photo 3: The middle section of the kalderimi from Lafkos to Milina, just below the above chapel. As can be seen from the photo, part of this path has been washed away, but is still passable, though potentially a little dangerous as now a relatively steep drop to the side.

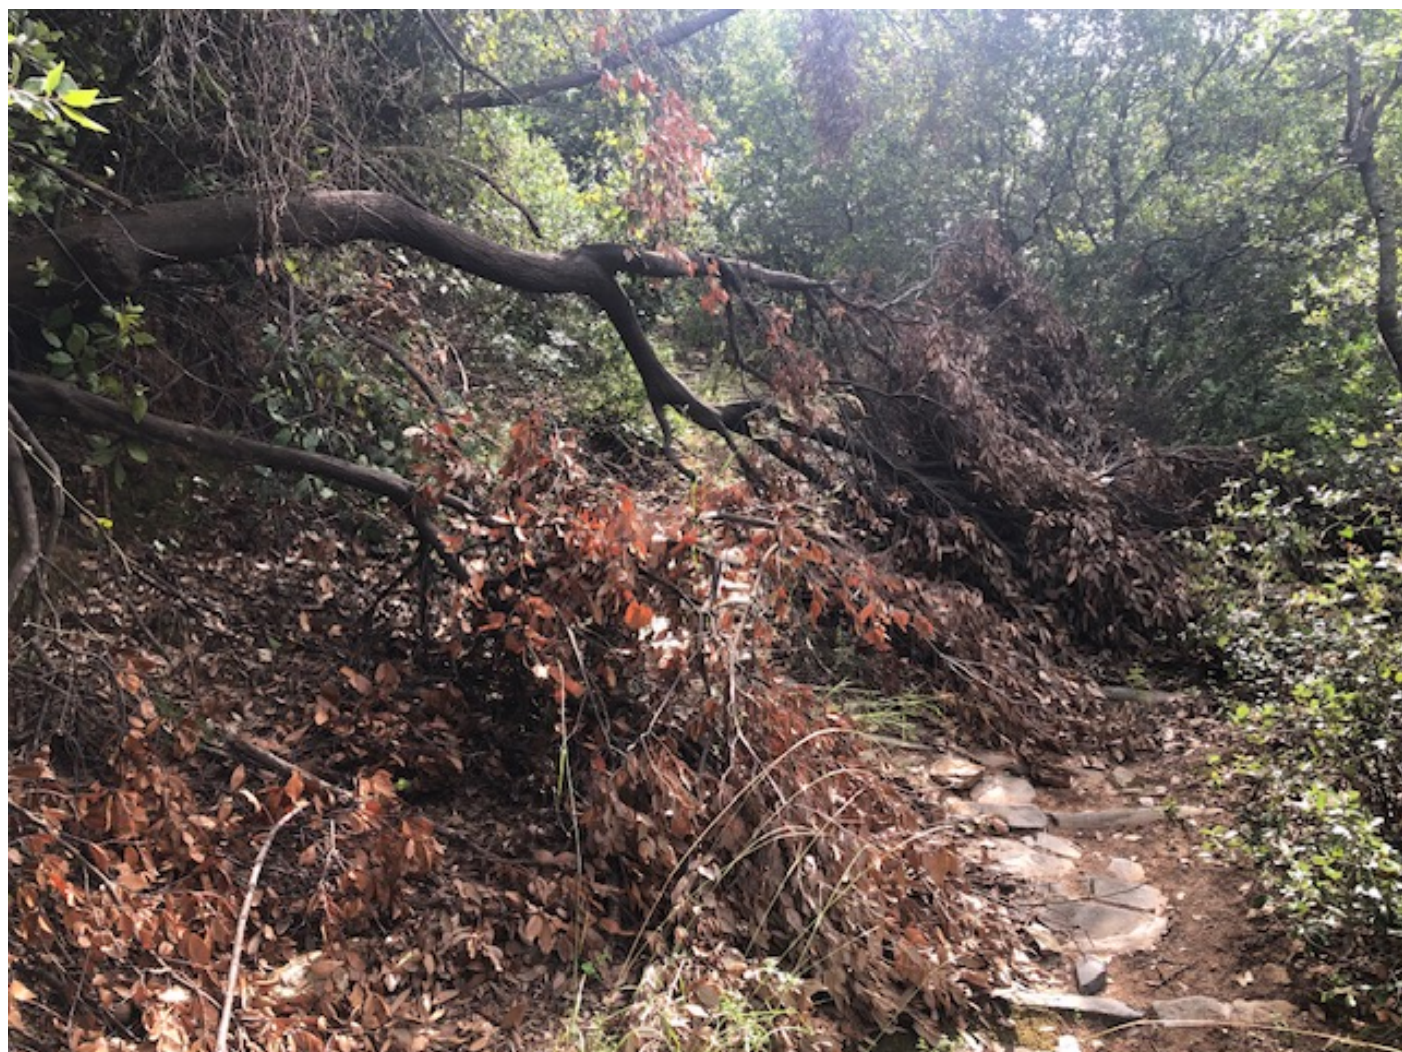
Photos 4 and 5 - relate to the middle path from Milina to Lafkos- the final section from the Milina to Lafkos road to Lafkos. The first section from the edge of Milina was all passable (just silt and loose stones in parts).

Photo 4: Fallen tree across the path - whilst blocking the path, it is still possible to climb through the fallen tree.

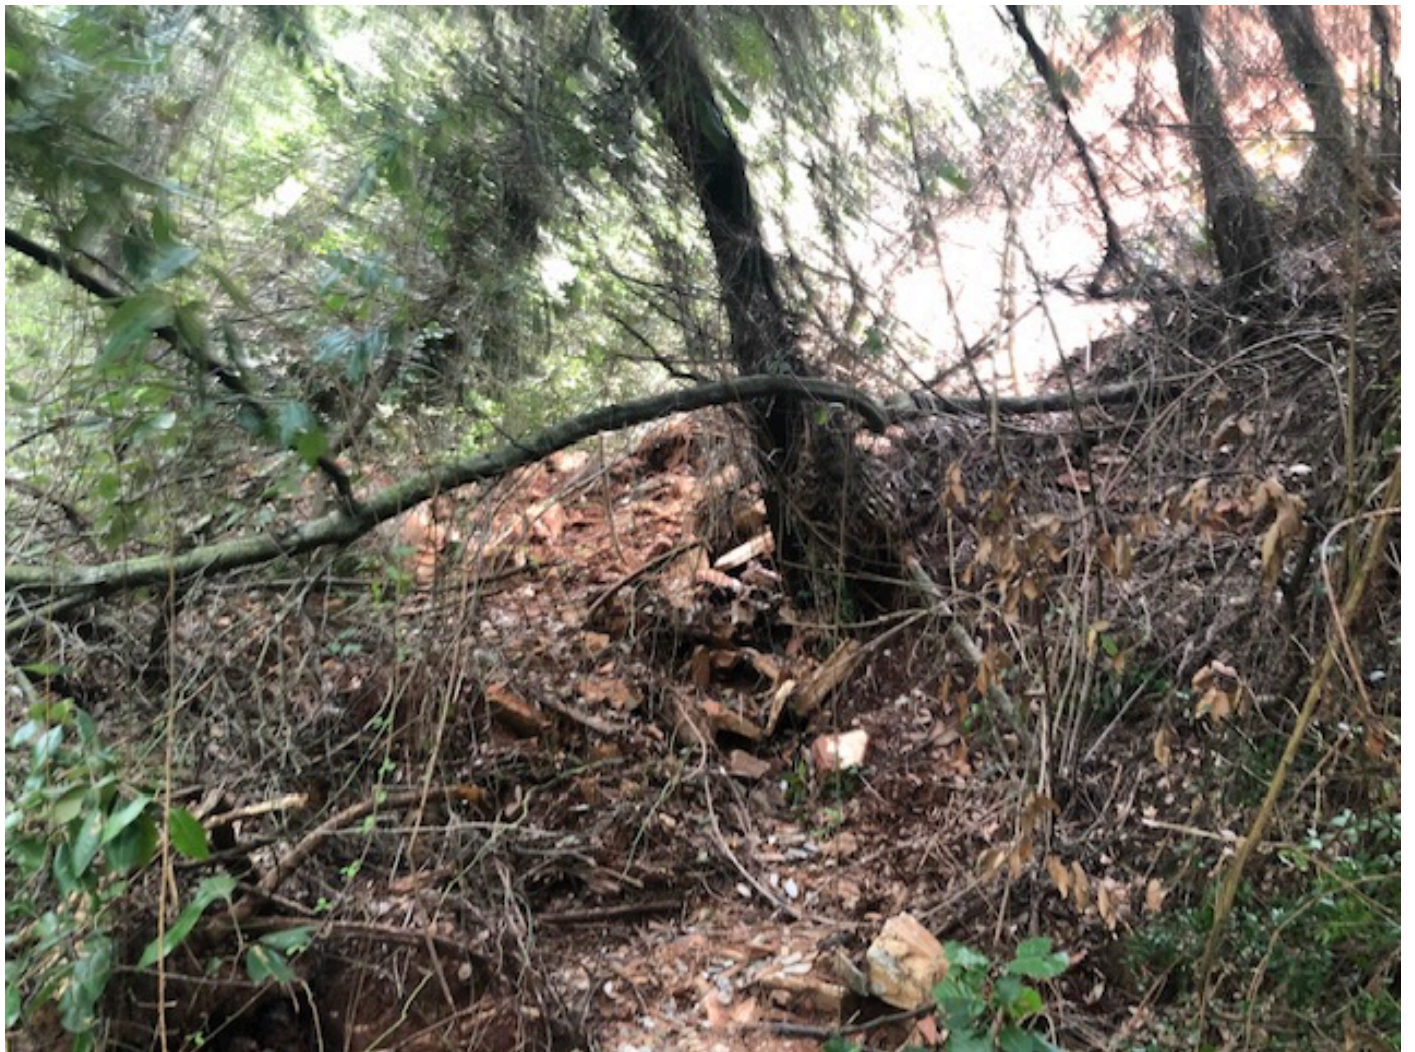
Photo 5: This section of the path (approximately 1,000 to 1,500 m) along this section of the kalderimi, is totally blocked and inaccessible as a result of a landslide. One side of the path is a steep drop into the gully below and the other side is blocked by dense vegetation.
