Route **Metochi - Lafkos**
Checked by **David Lewis**
Date **24 September 2023**
Condition **Difficult in places, passable with caution**

Starting from the Metochi - Lafkos road (by the large map signpost)

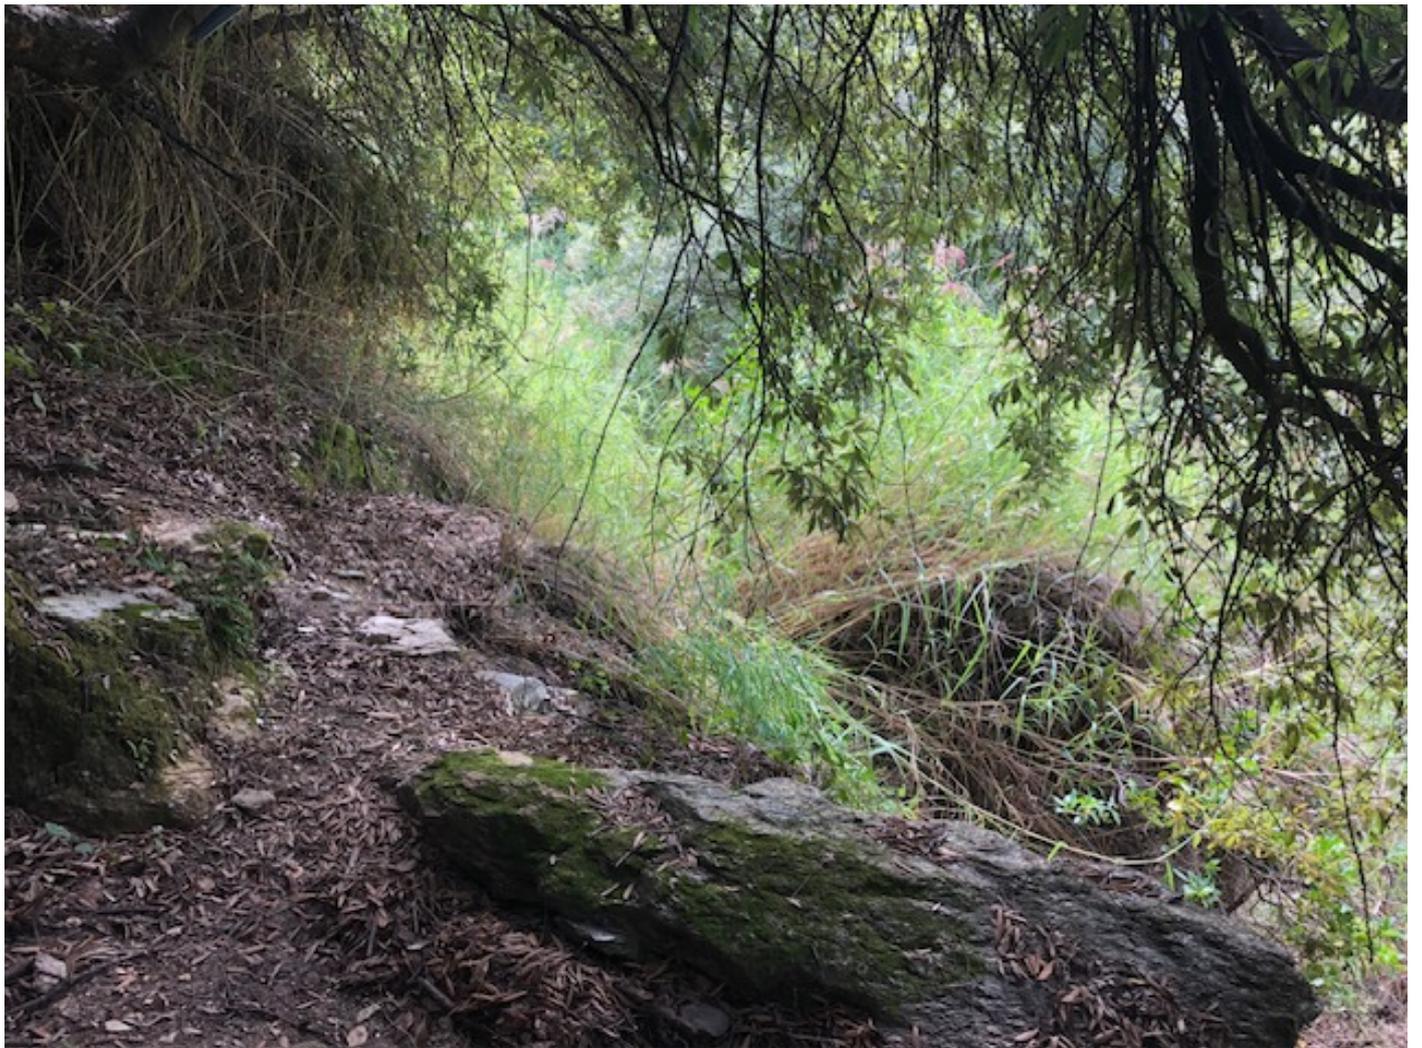
Photo 6 relates to the section of path just beyond the track leading to the solar farm (the one to the west of the road). This is a narrow little path that is starting to become overgrown. Approximately 750 m along this section of path, the path seems to come to a halt (just beyond a stoned section over a stream). It was not clear to the walker, whether this was the finish of the path is as a result of being overgrown or a minor landslide. It will be re-checked.

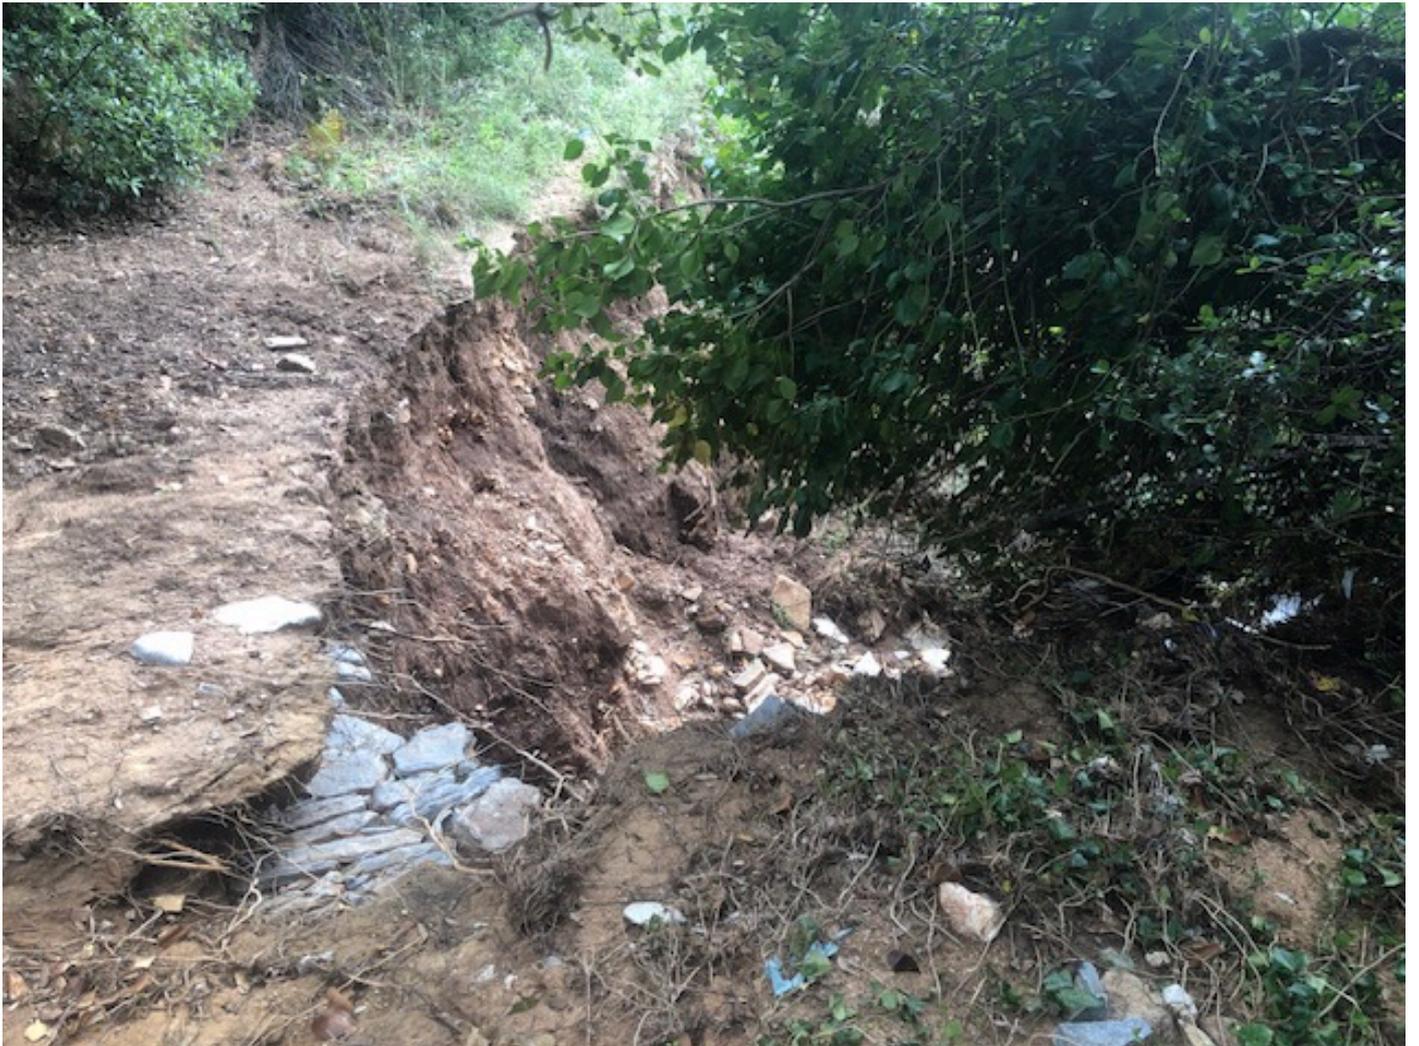
Photo 7 shows a section of the track (approximately 200 or 300m along this section), washed away. The track is still passable but does pose a safety risk.

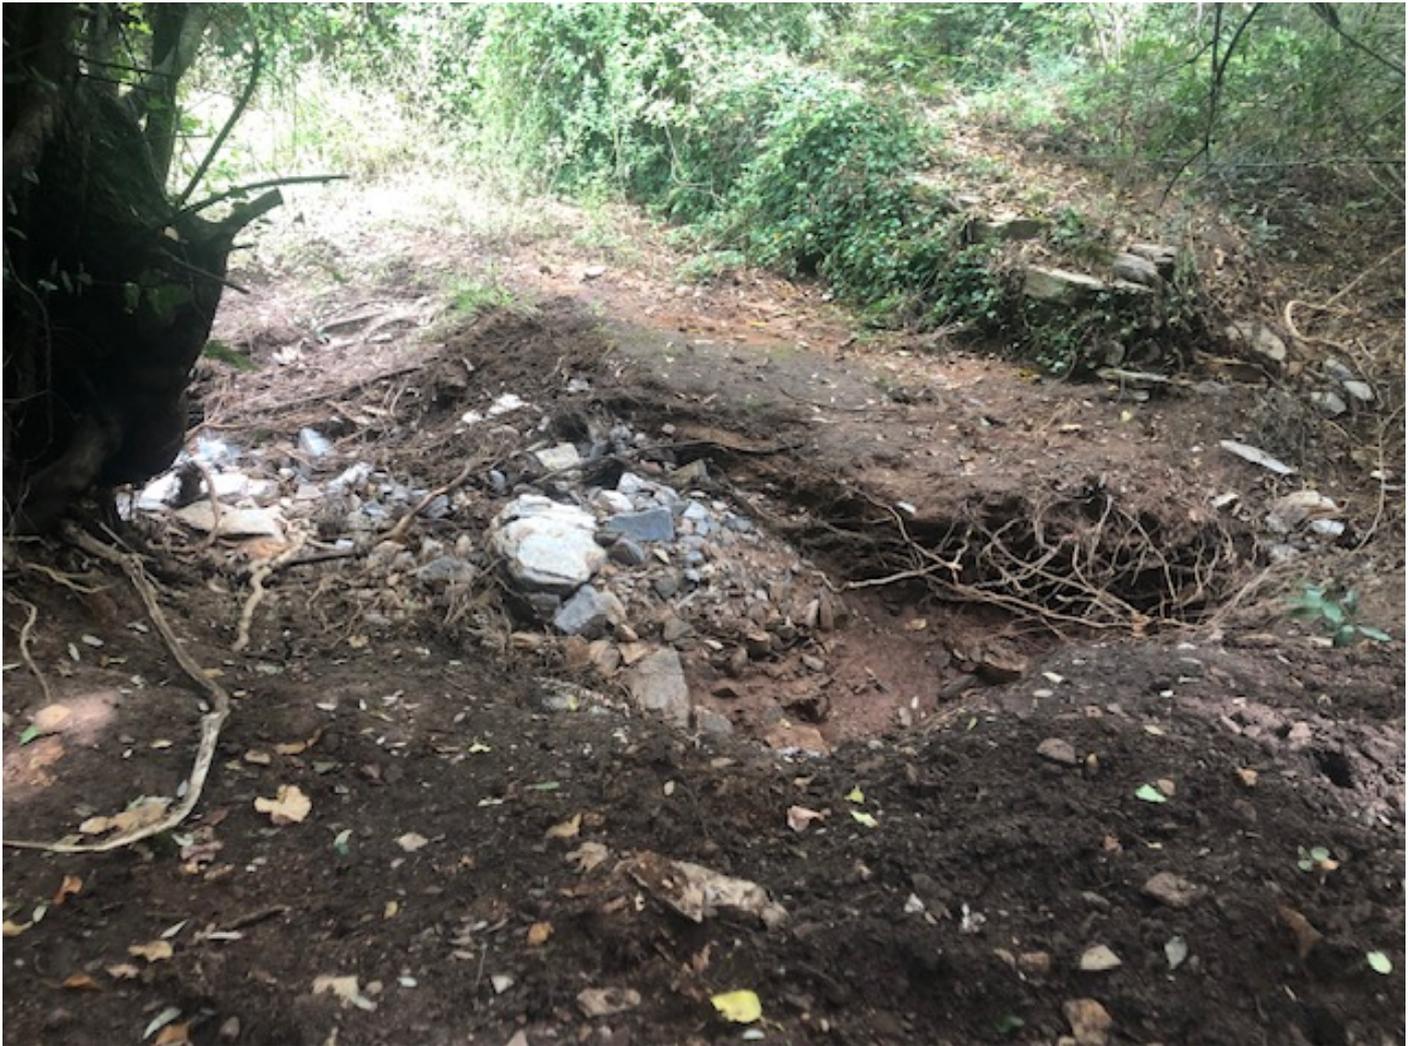
Photo 8 shows part of the track that has been washed away. It is still passable.

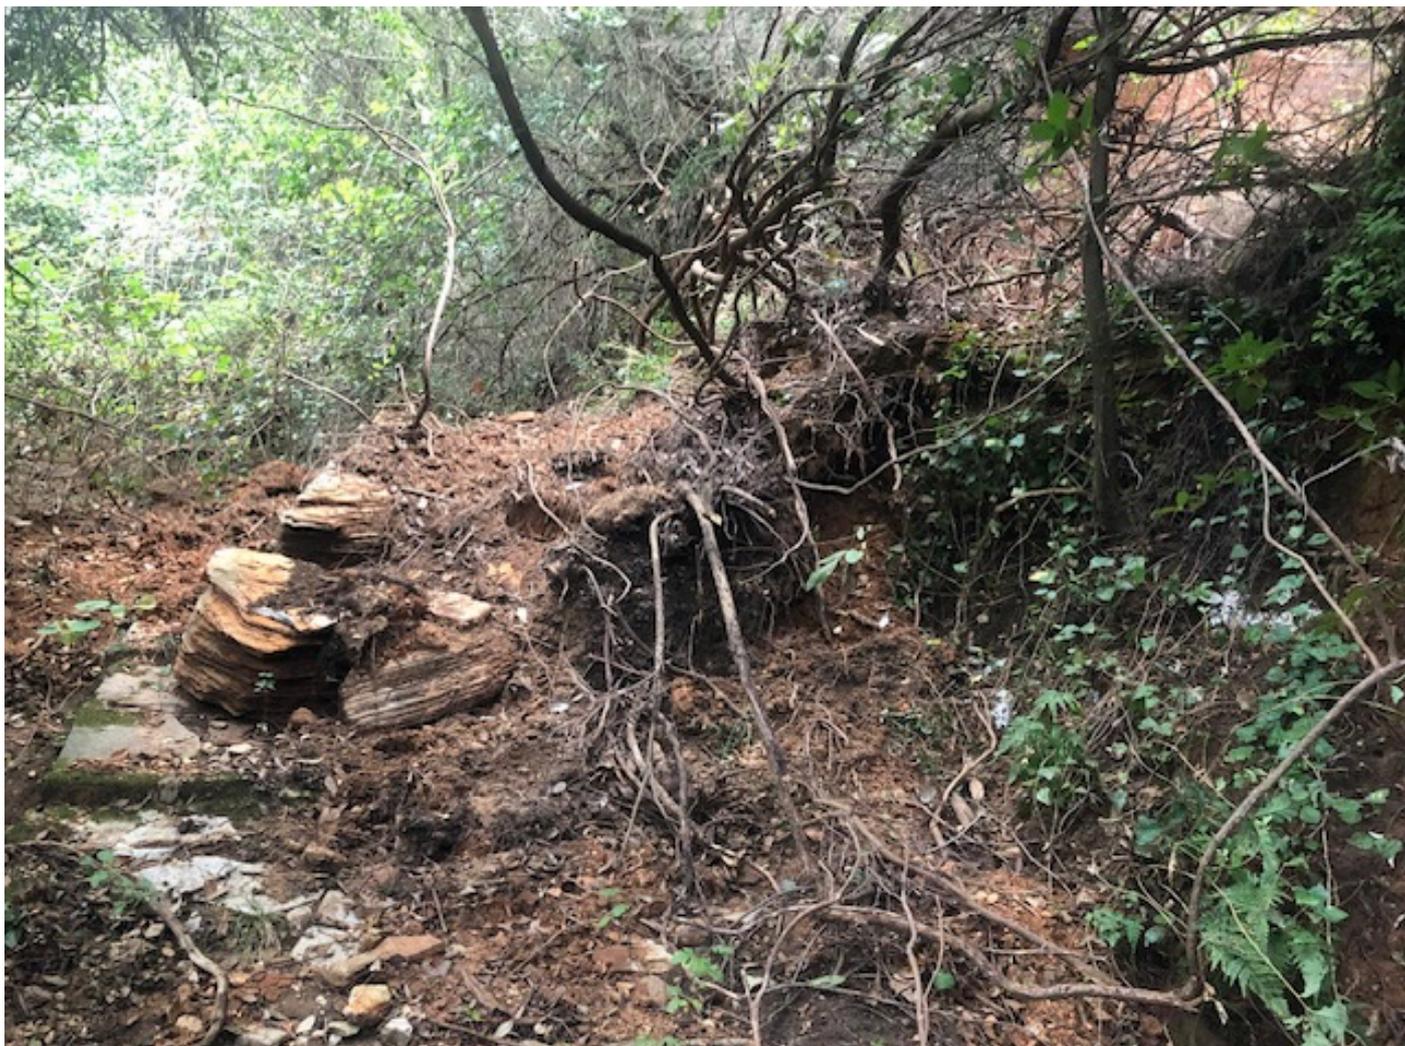
Photo 9 shows a blocked section of the track as a result of a landslide. It is approximately 750m along the track. It was possible to get past this blockage by climbing up the hillside and pushing through tree branches and undergrowth. It is not recommended.
