**Διαδρομή**            **Λαύκος - Μηλίνα - Λαύκος**  
**Ελέγχθηκε από** **David Lewis**  
**Ημερομηνία**        **24 Σεπτεμβρίου 2023**  
**Κατάσταση**        **One route passable with caution, one route not passable**

*Routes A and B, Lafkos - Milina and Milina - Lafkos*

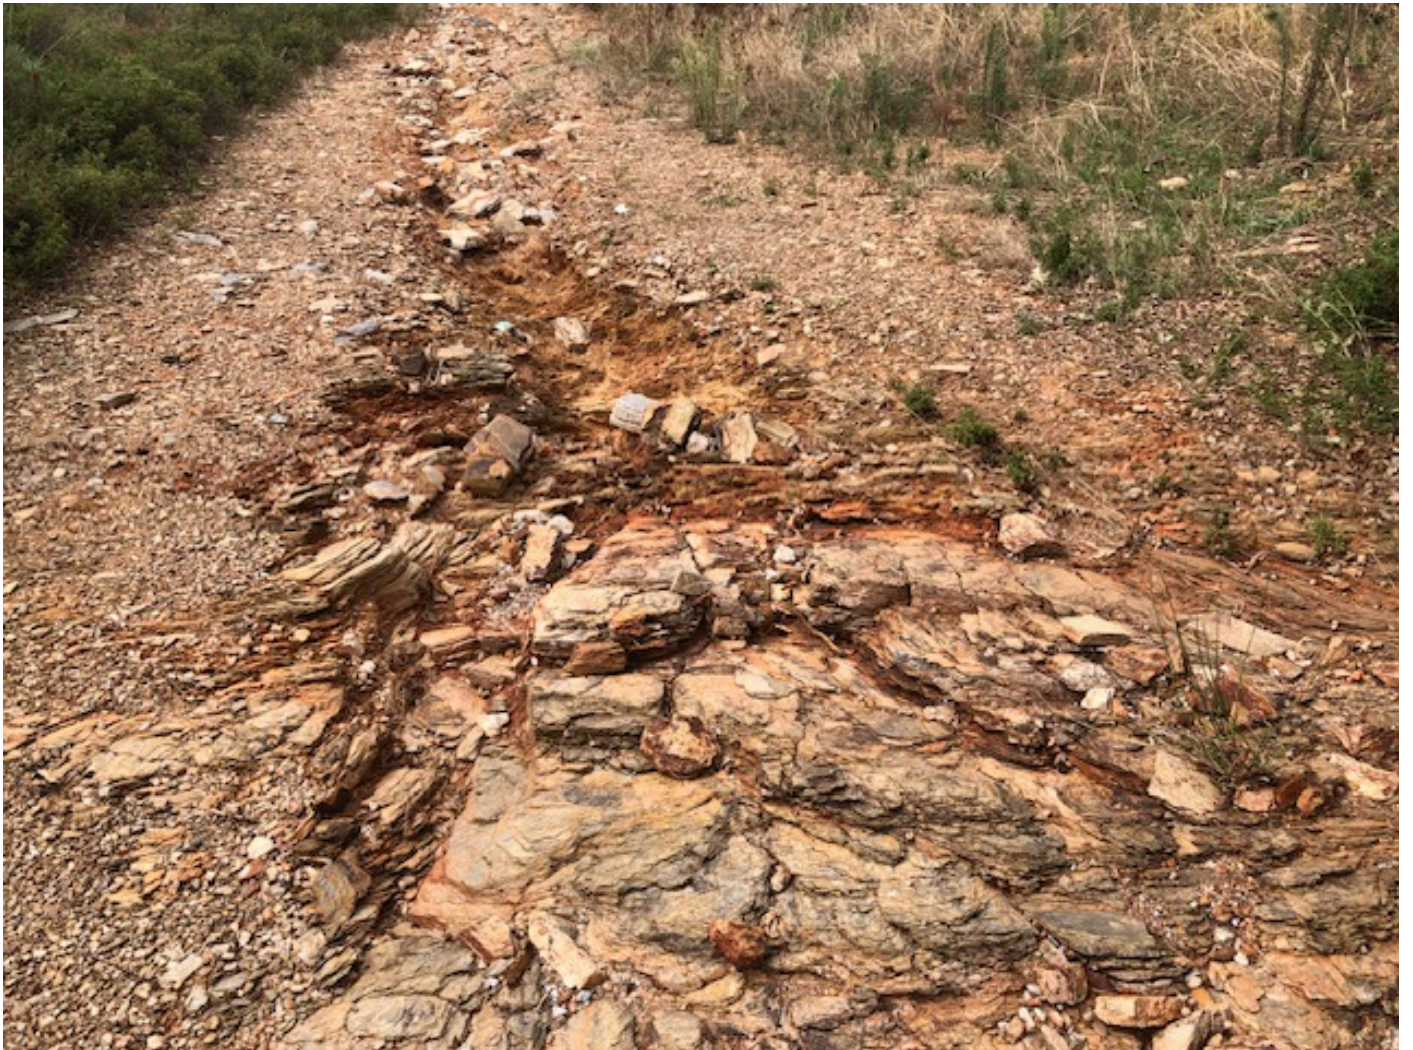
Photo 1: This is the top section of the main kalderimi path from Lafkos to Milina (Chorto side). As you can see from the photo, the path is still very passable but the rain has brought silt onto the path and washed off the stones from the centre of the path.

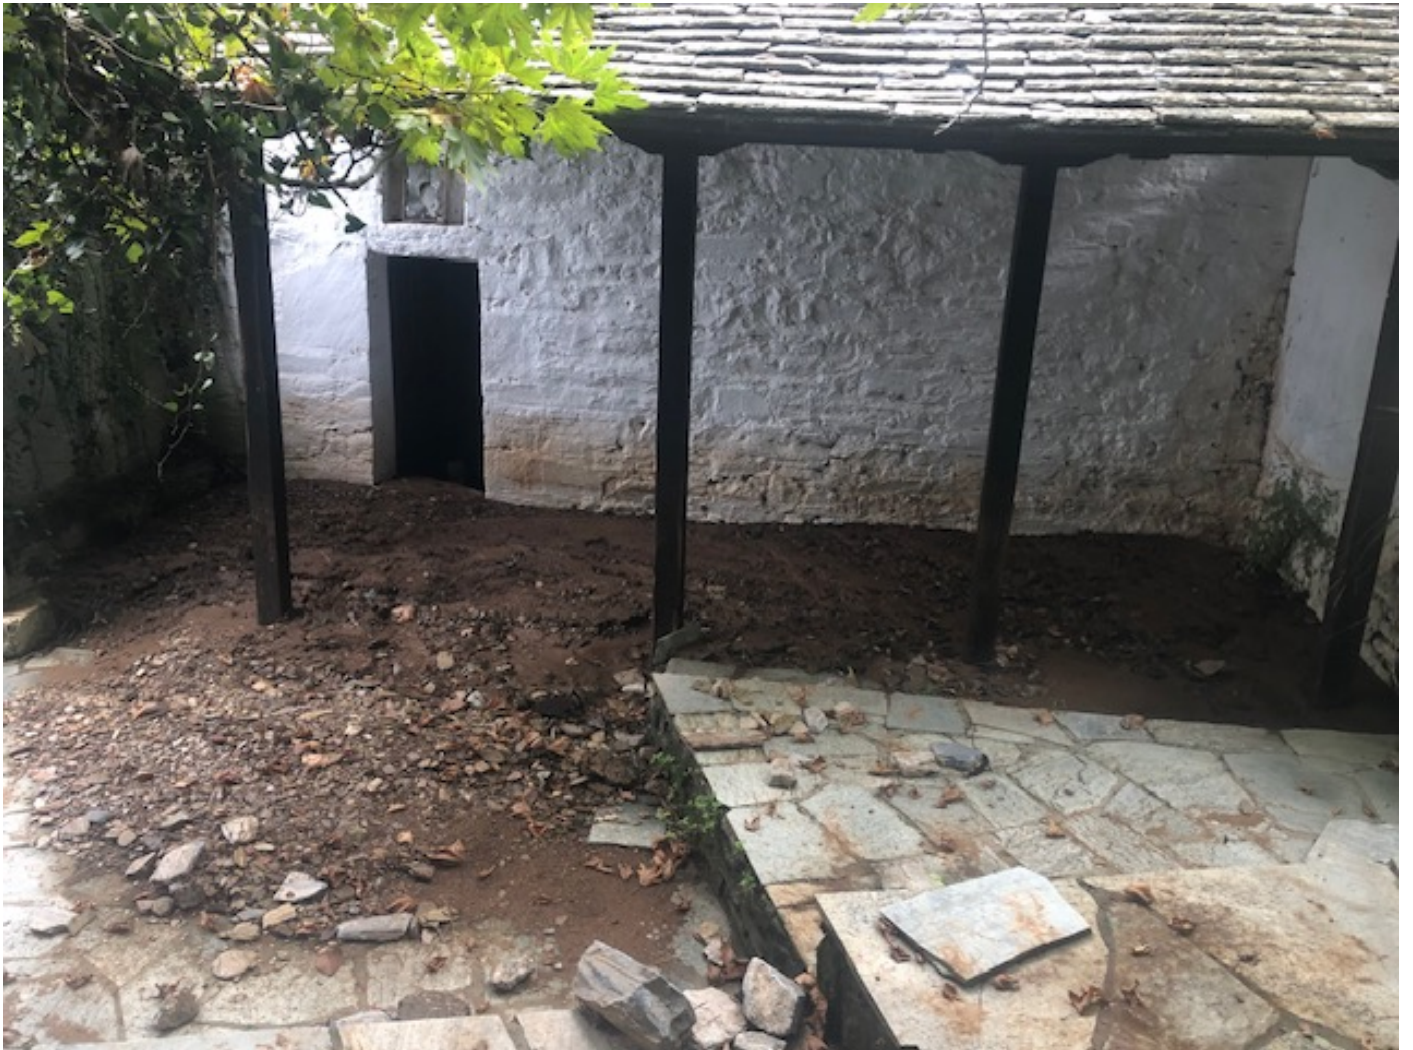
Photo 2: The middle section of the kalderimi from Lafkos to Milina, where the little chapel is located. As can be seen from the photo lots of soil/ silt has been washed down the hill and collected outside the chapel. There is also silt and water inside the chapel which will damage the floor and objects inside.

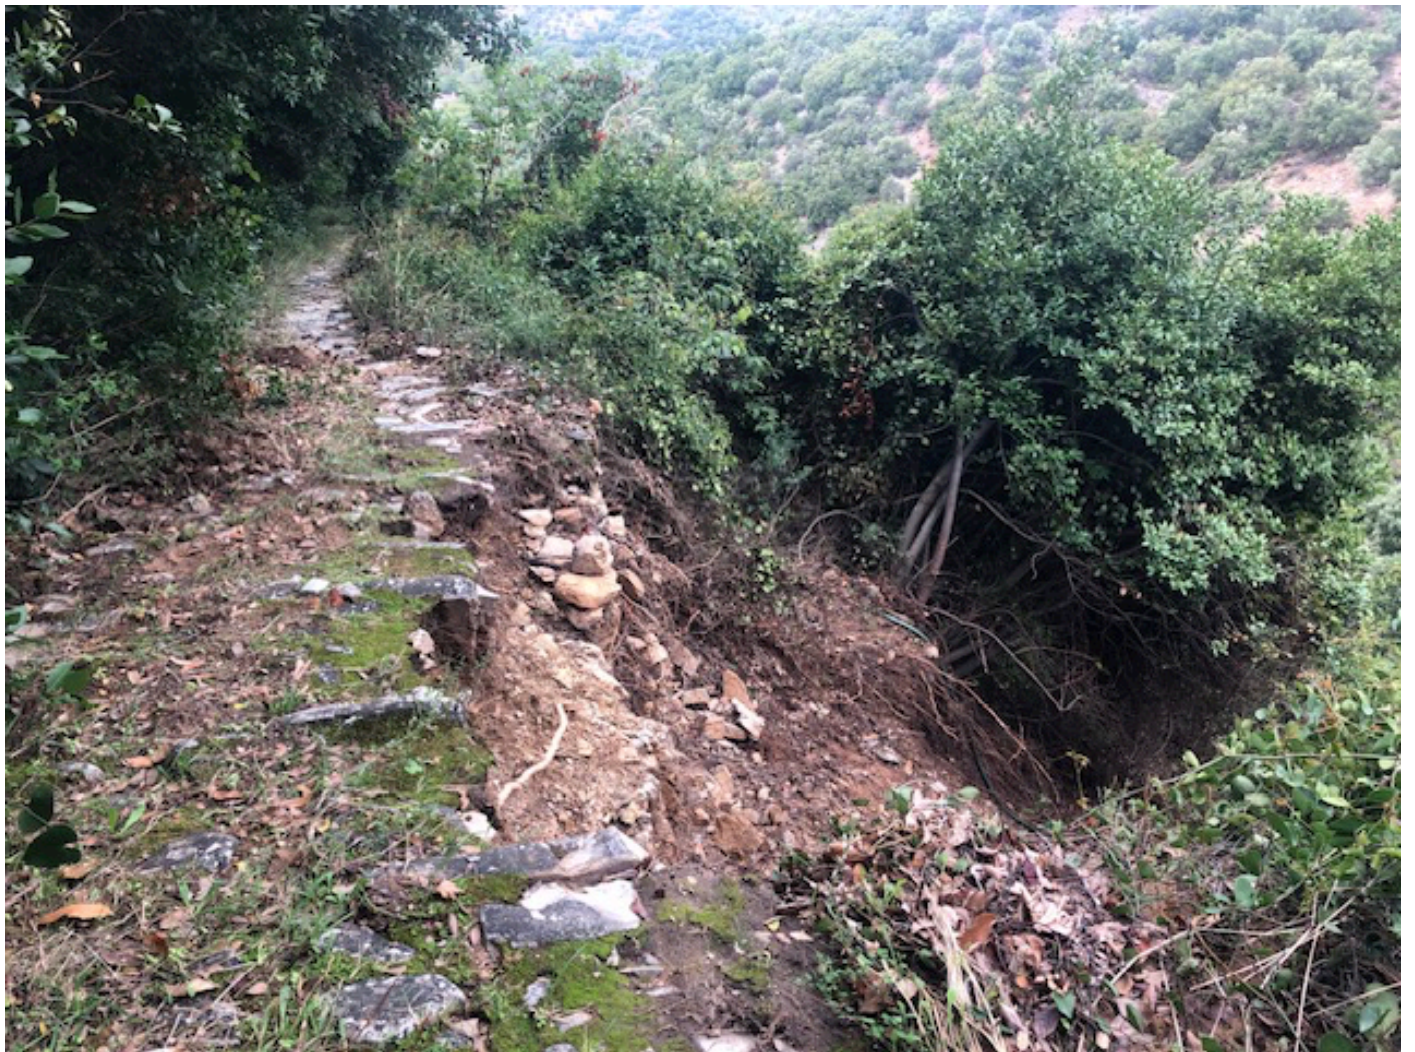
Photo 3: The middle section of the kalderimi from Lafkos to Milina, just below the above chapel. As can be seen from the photo, part of this path has been washed away, but is still passable, though potentially a little dangerous as now a relatively steep drop to the side.

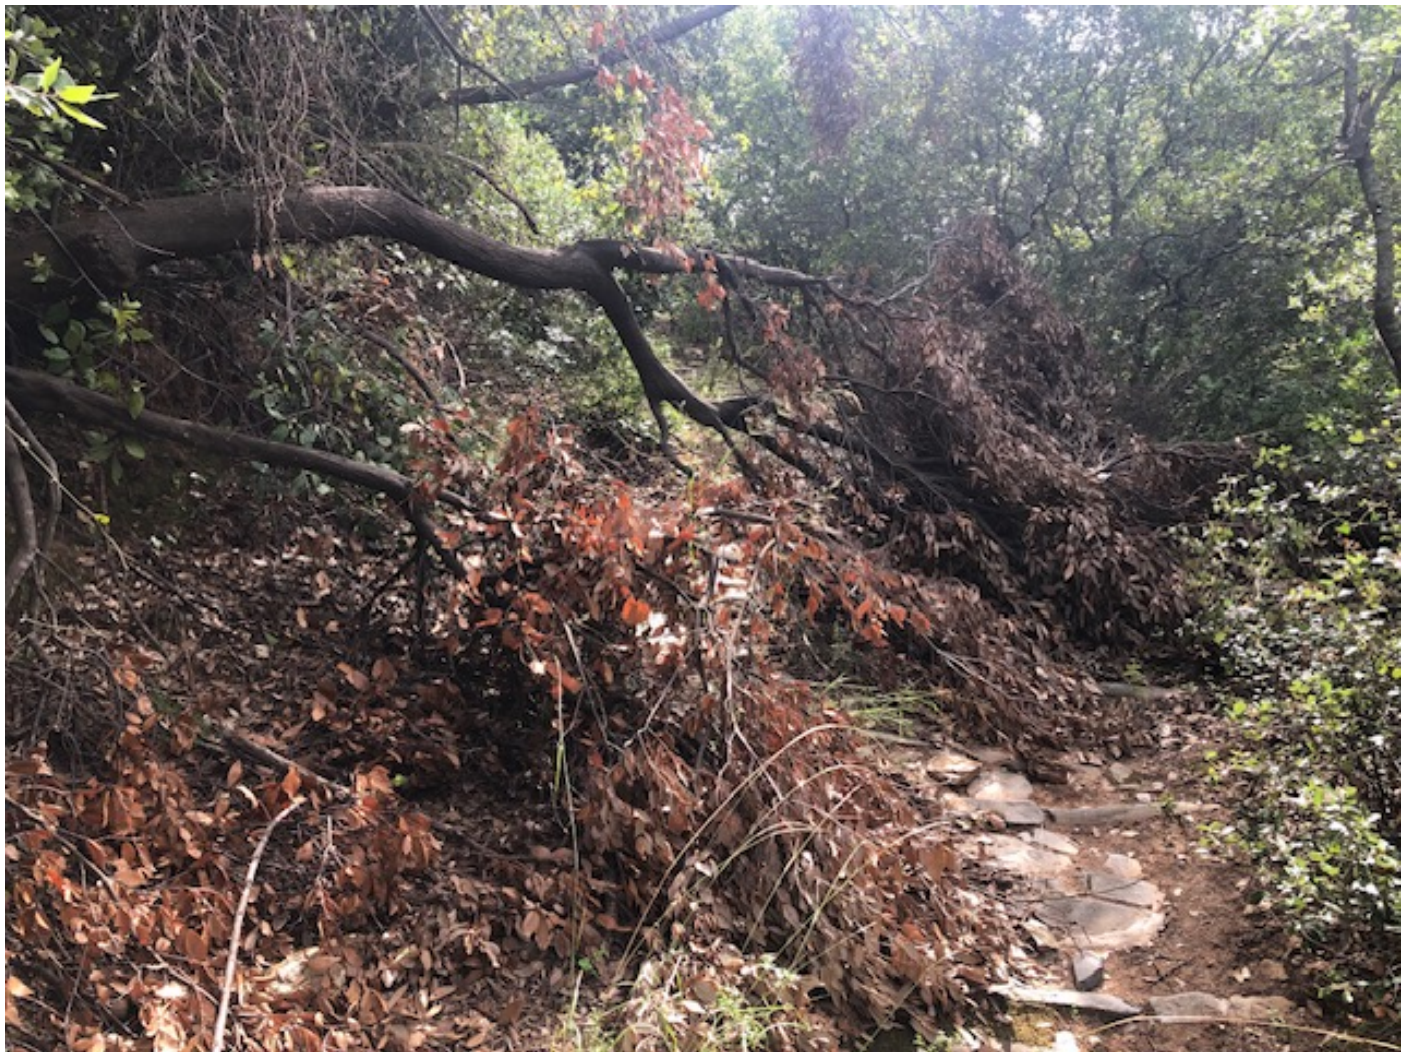
Photos 4 and 5 - relate to the middle path from Milina to Lafkos- the final section from the Milina to Lafkos road to Lafkos. The first section from the edge of Milina was all passable (just silt and loose stones in parts).

Photo 4: Fallen tree across the path - whilst blocking the path, it is still possible to climb through the fallen tree.

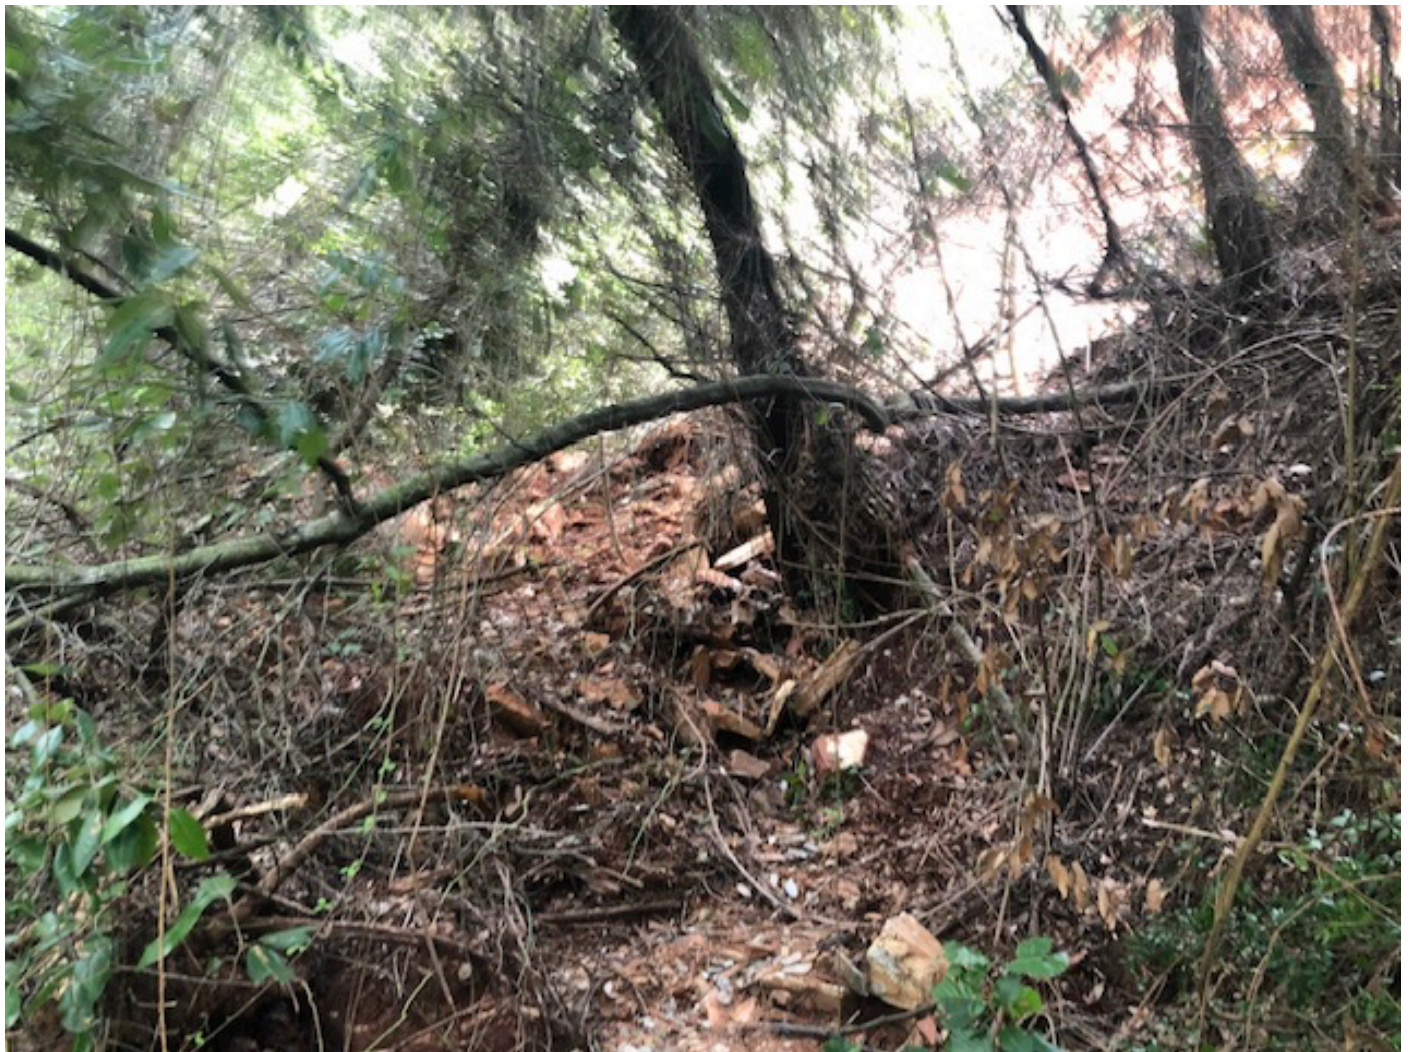
Photo 5: This section of the path (approximately 1,000 to 1,500 m) along this section of the kalderimi, is totally blocked and inaccessible as a result of a landslide. One side of the path is a steep drop into the gully below and the other side is blocked by dense vegetation.
