Διαδρομή **Μετόχι - Λαύκος**  
Ελέγχθηκε από **David Lewis**  
Ημερομηνία **24 Σεπτεμβρίου 2023**  
Κατάσταση **Δύσκολο κατά τόπους, περπατιέται με προσοχή**

## Η περιγραφή του περπατήματος

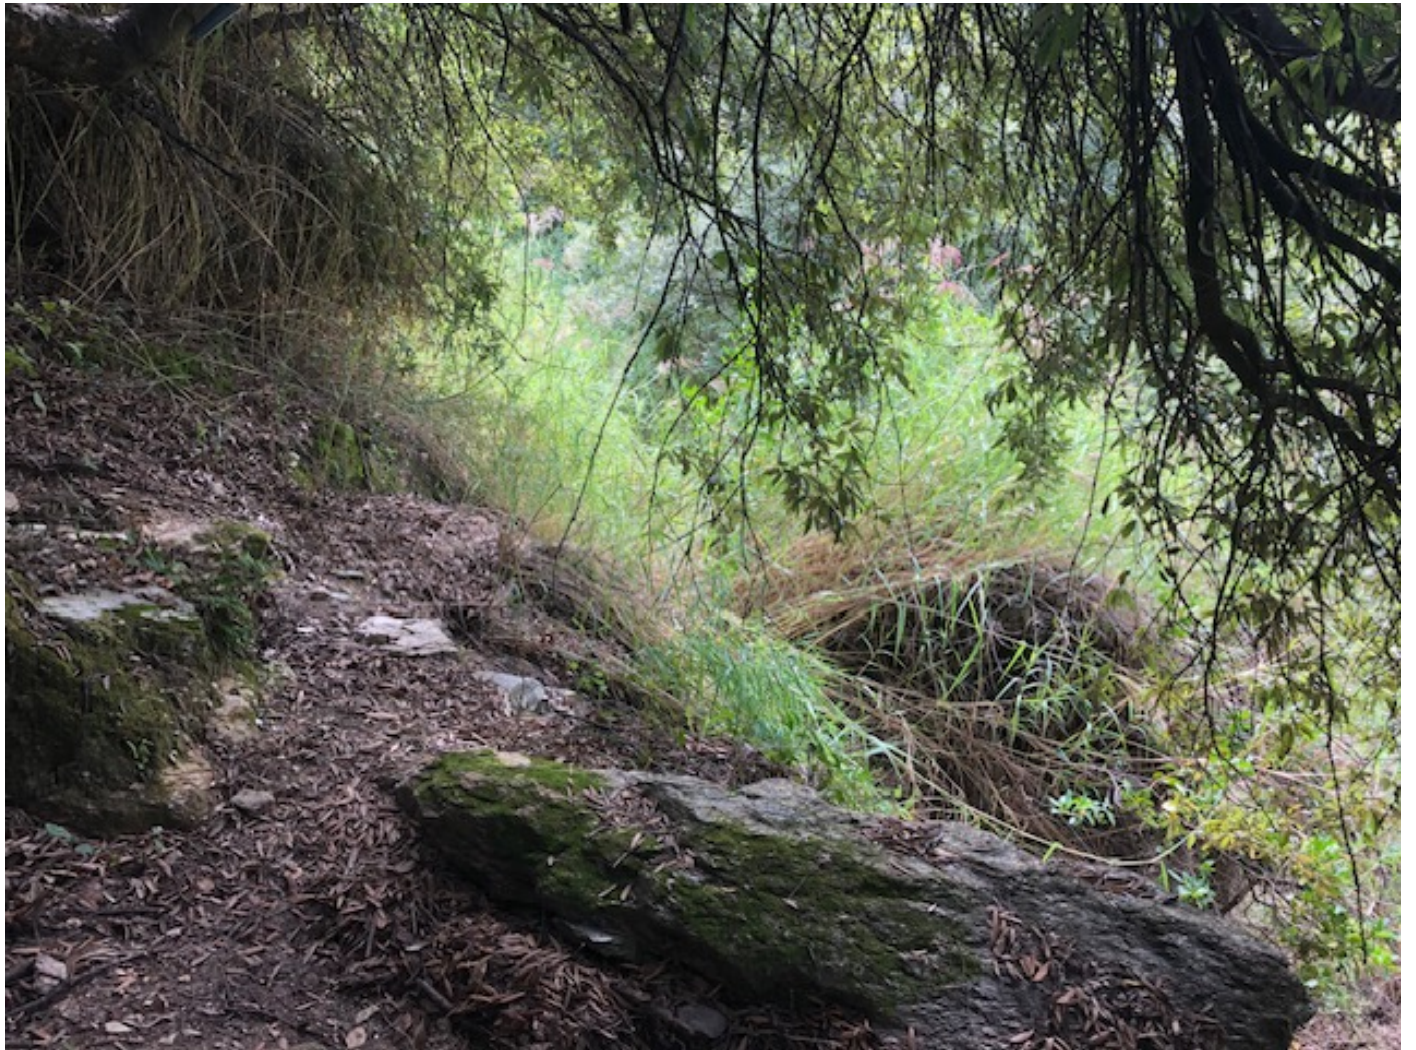
Photo 6 relates to the section of path just beyond the track leading to the solar farm (the one to the west of the road). This is a narrow little path that is starting to become overgrown. Approximately 750 m along this section of path, the path seems to come to a halt (just beyond a stoned section over a stream). It was not clear to the walker, whether this was apparent finish of the path is as a result of being overgrown or a minor landslide. It will be re-checked.

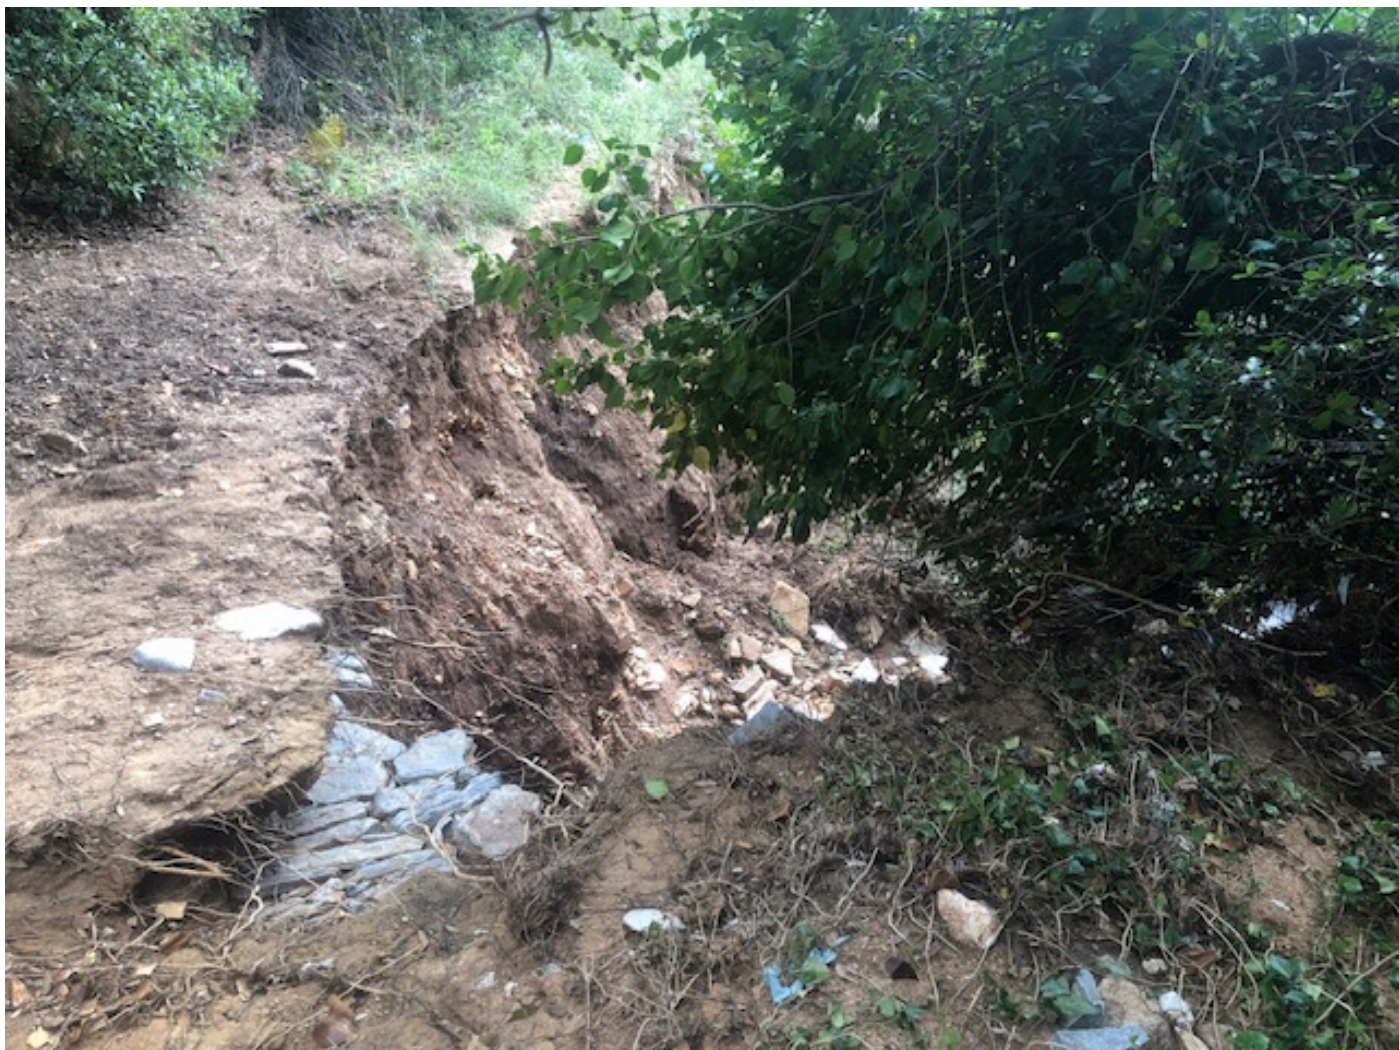
Photo 7, 8, and 9 relates to the final section of the path leading to Lafkos. (The other sections were all passable and in reasonable condition apart from a few loose stones and coverings of mud washed down on to the tracks).

Photo 7 shows a section of the track (approximately 200 or 300m along this section), washed away. The track is still passable but does pose a safety risk.

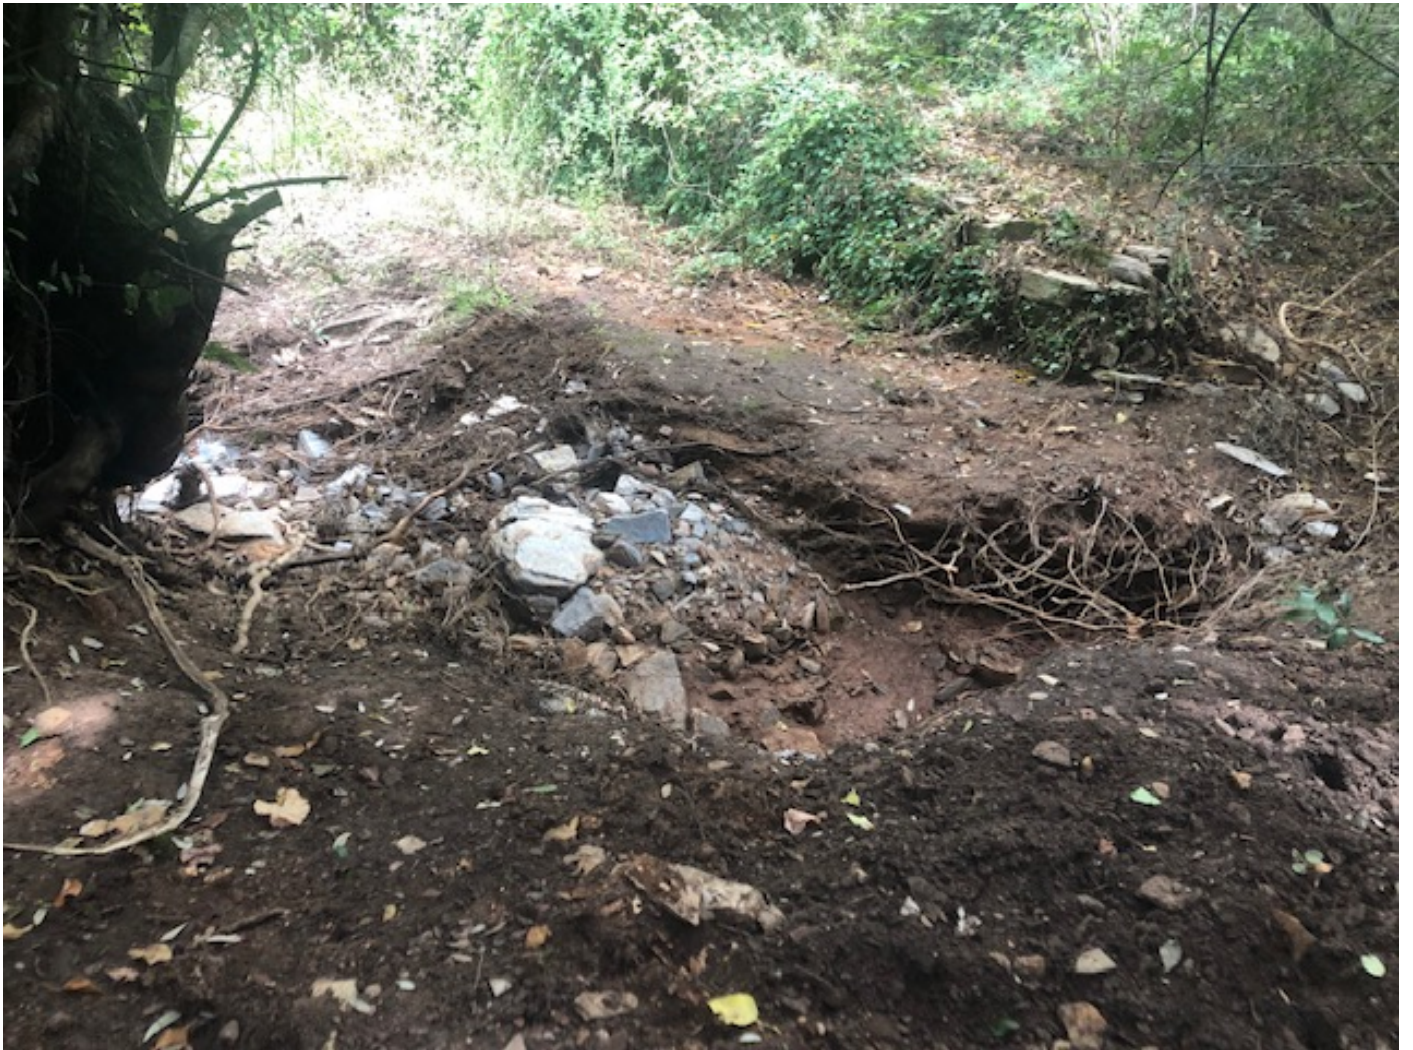
Photo 8 shows part of the track that has been washed away. It is still passable.

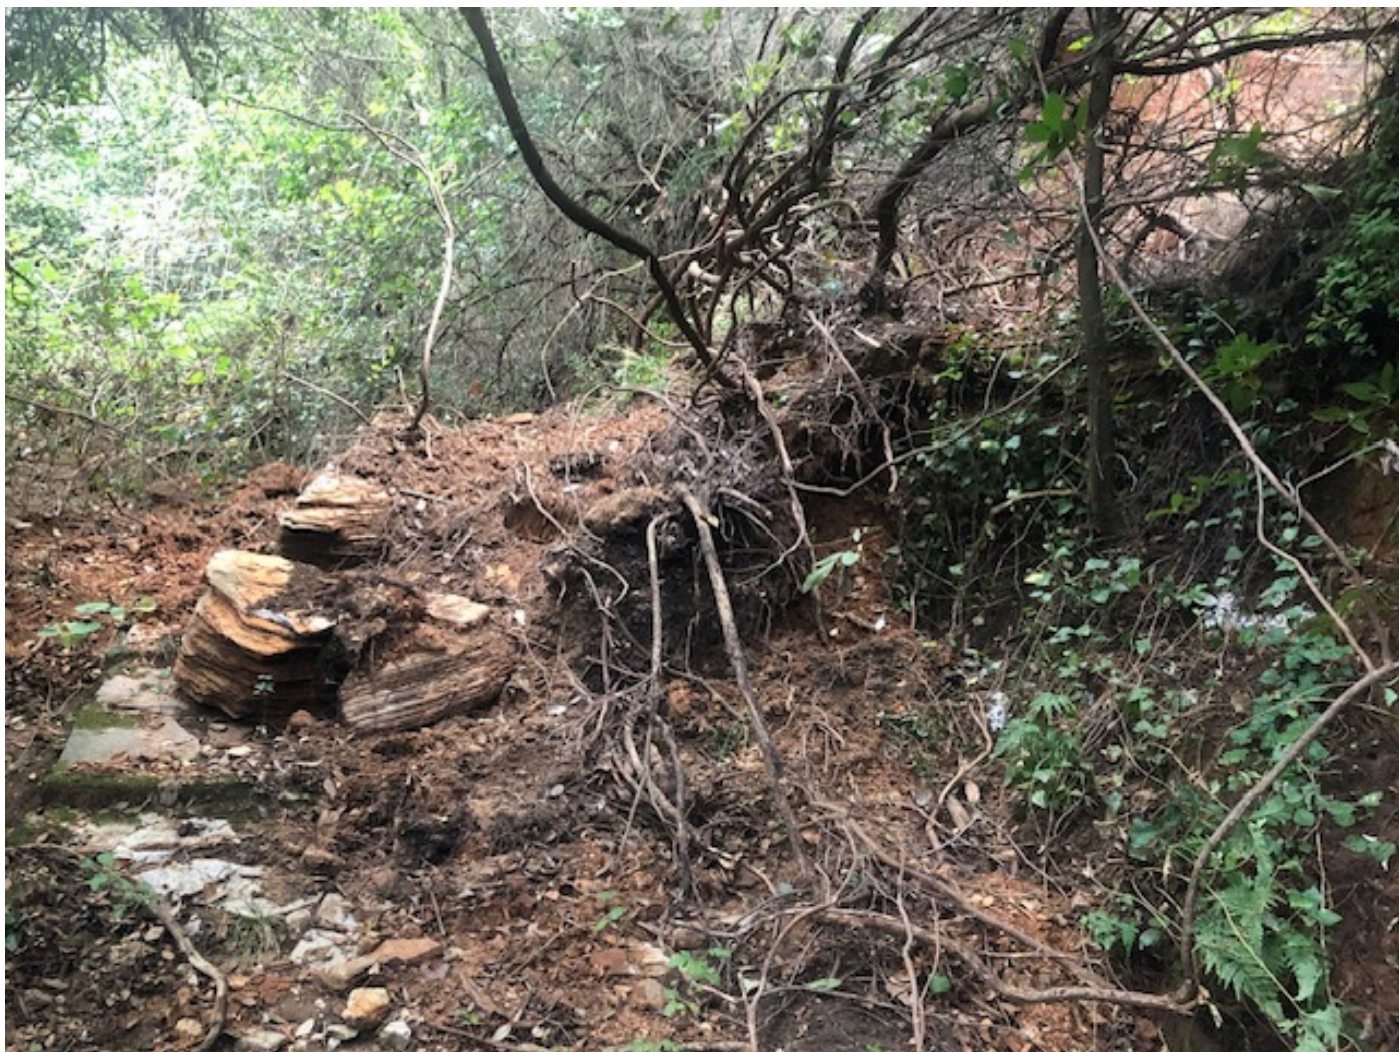
Phone 9 shows a blocked section of the track as a result of a landslide. It is approximately 750m along the track. It was possible to get past this blockage by climbing up the hillside and pushing through tree branches and undergrowth. It is not recommended.
